# Sideling Hill Rock Cut Construction Management at Risk (CMAR) Project

CONTRACT: WA2515176  
INFORMATIONAL MEETING  
AUGUST 17, 2016

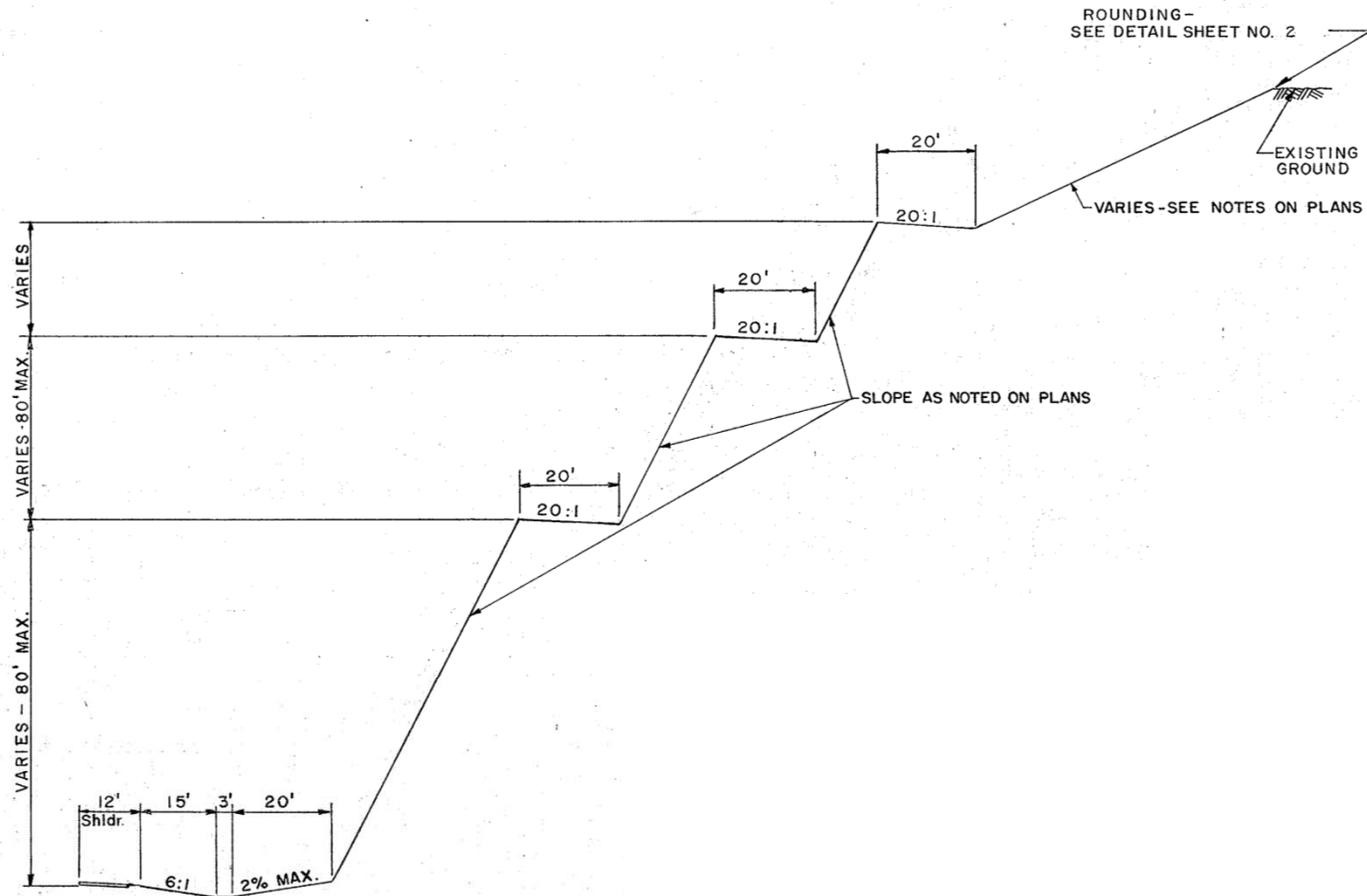
# Typical Section per Original Plans

## ROCK FALL BENCH DETAIL

Scale 1" = 20'  
STA. 2477+50 TO STA. 2499+00, RT. & CONSTR. U.S.48  
STA. 2479+50 TO STA. 2497+00, LT.

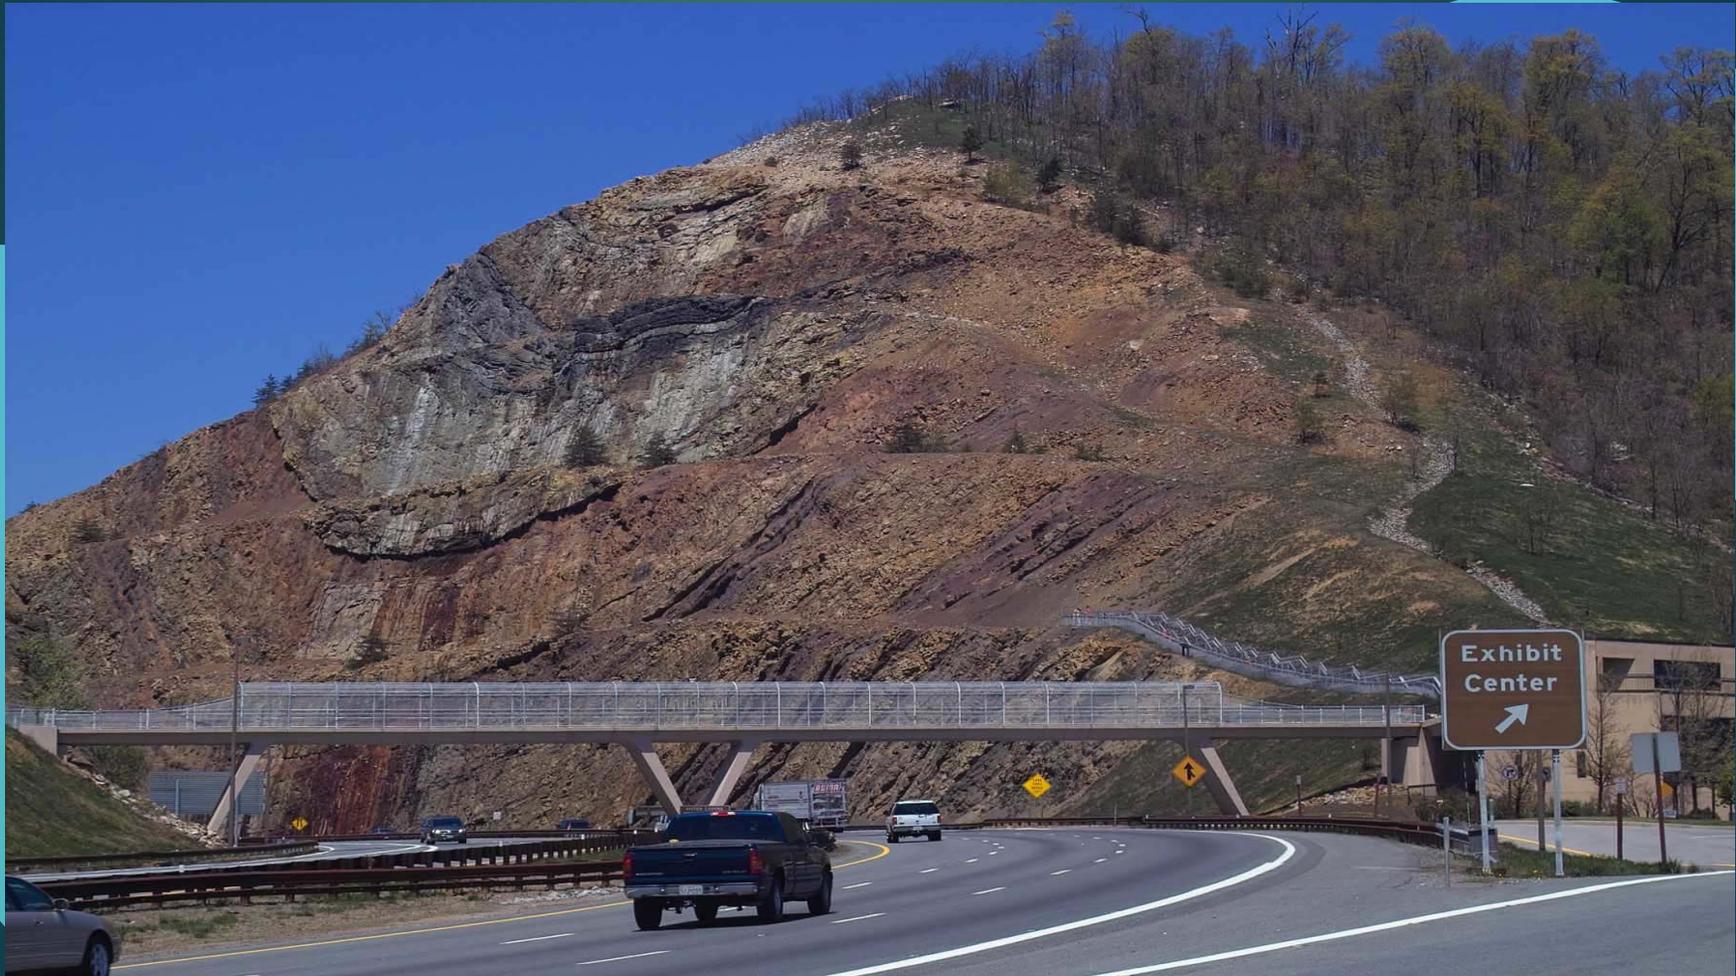
I-68 WB Northern Benches

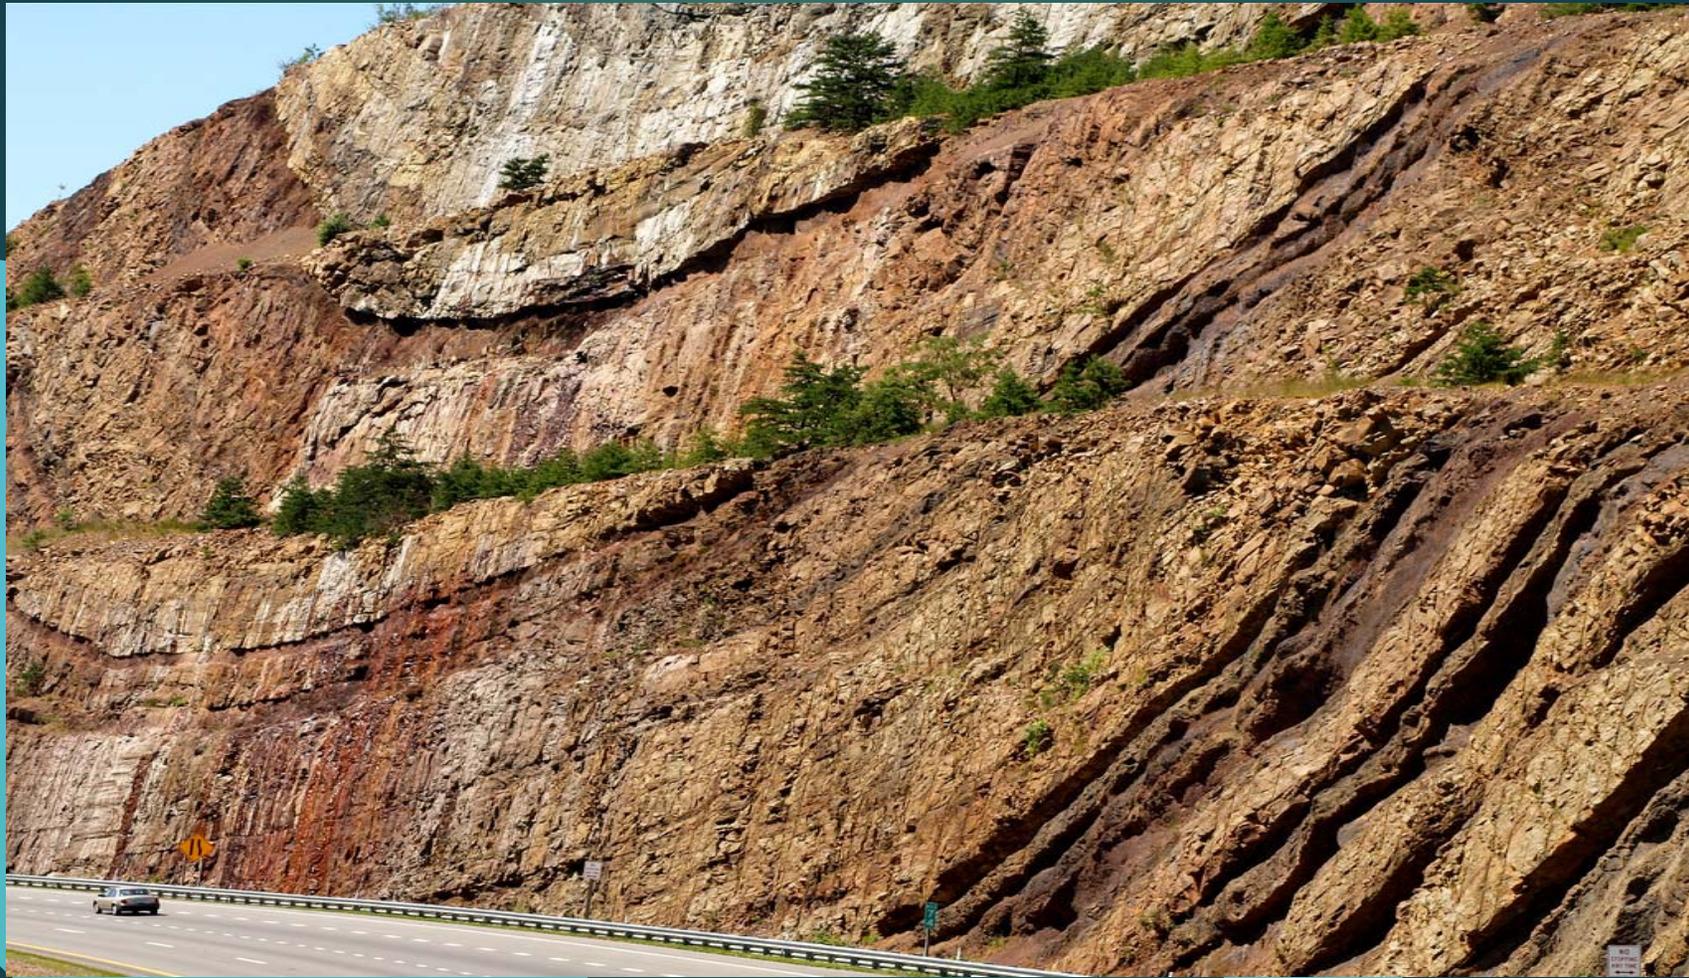
Northern Bench Vegetation and Rock Debris

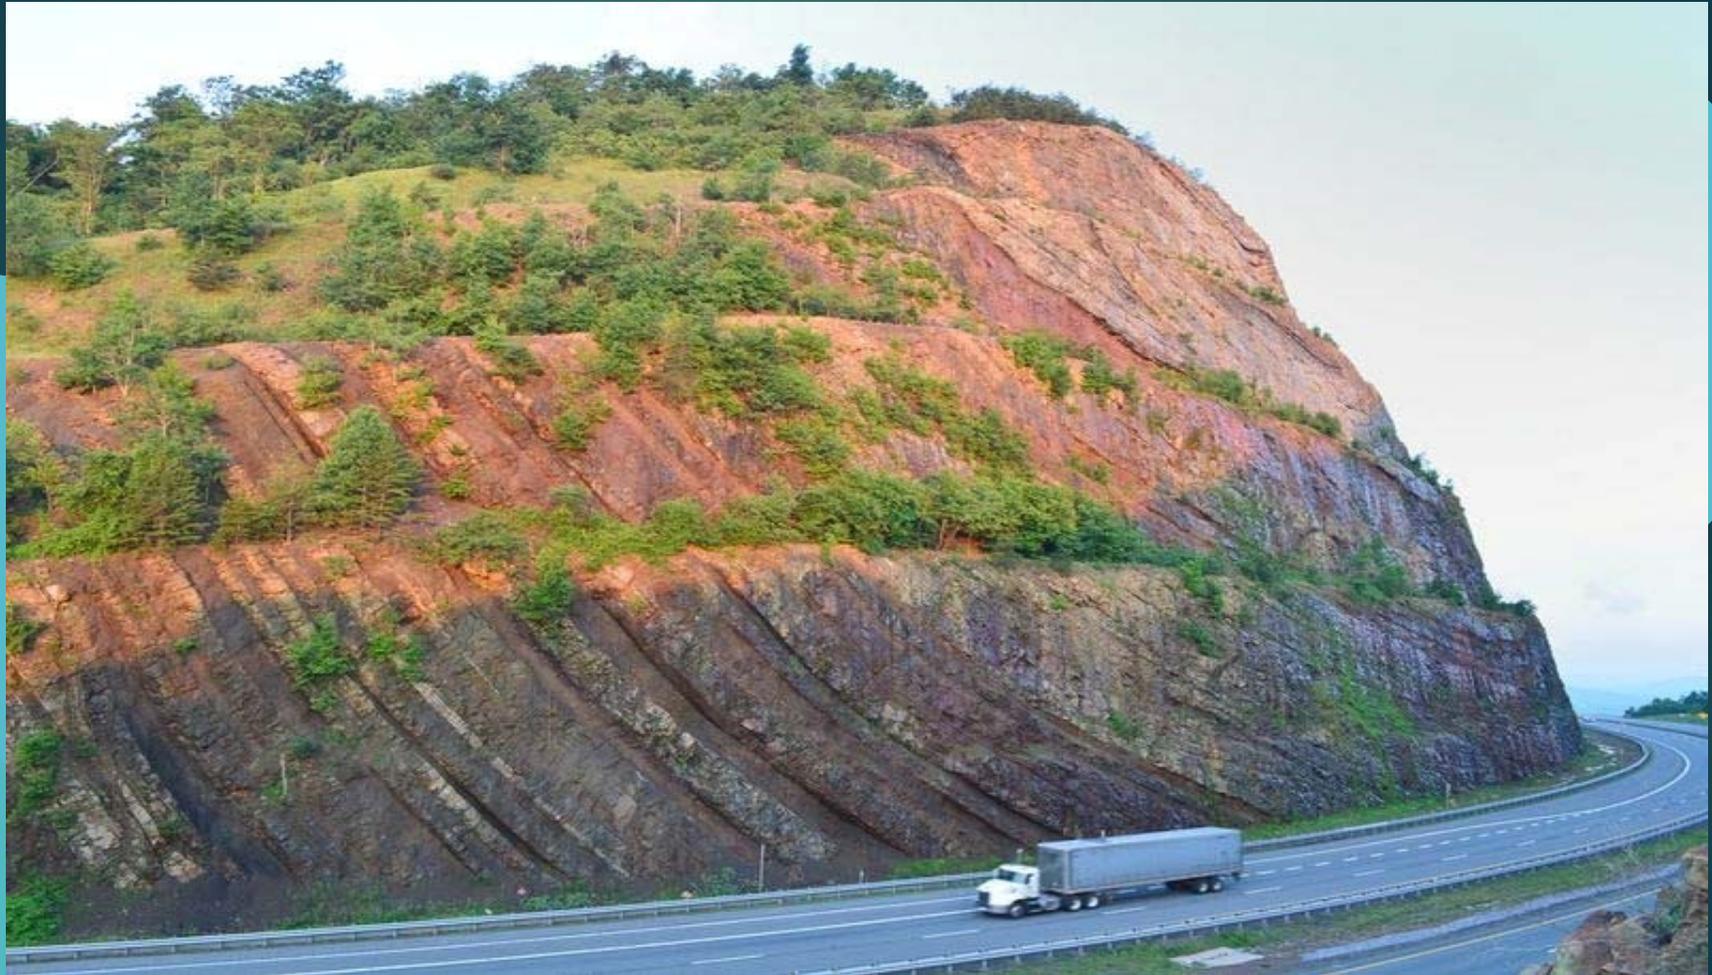
Southern Benches Vegetation and Rock Debris

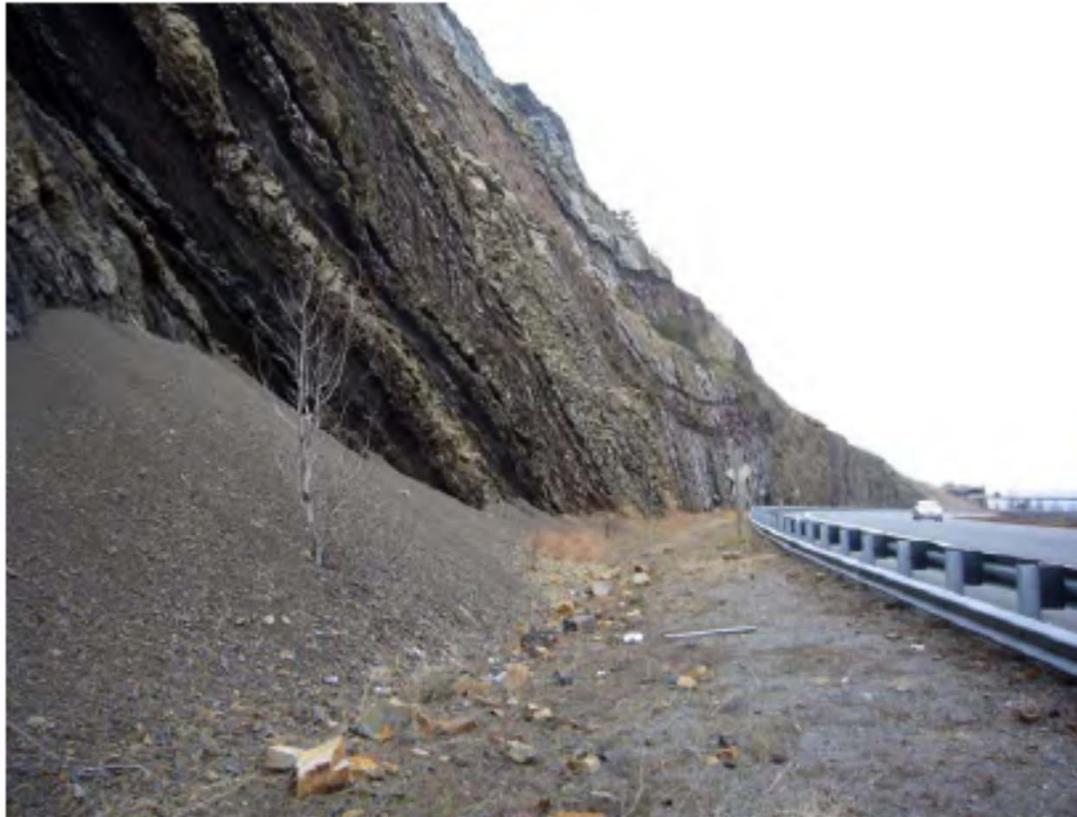
**PHOTOGRAPH No.:** 30

South Face, Toe of Slope,  
Approx. Station 2493+00; looking  
east

Severe differential weathering and undercutting in the Rockwell Formation will continue to degrade slope over time. Wedge of accumulated rock debris at toe may not need to be removed. Some small rockfall blocks in the catchment area are shown. Typical size is less than 0.5 ft wide.

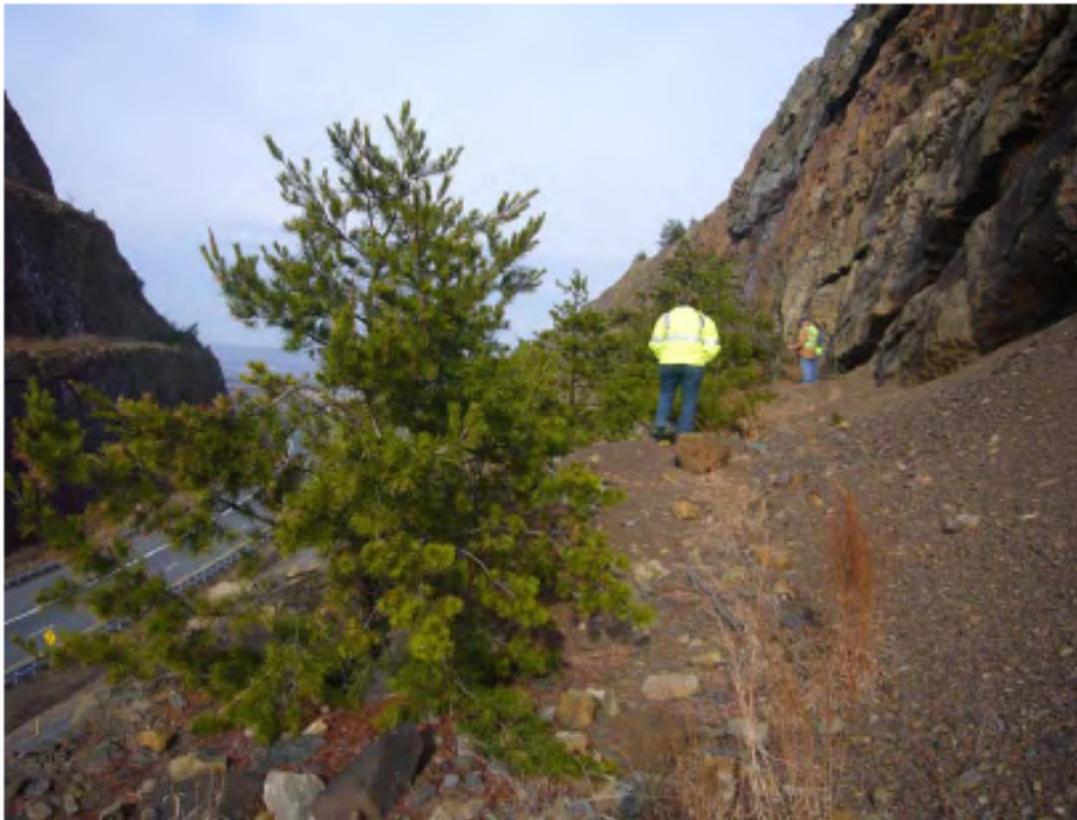
**PHOTOGRAPH No.: 4**

South Face, 1st Bench, Approx.  
Station 2485+00; looking west

Trees at edge of bench in steepest portions of the slopes should be removed. Wedge of rock debris on bench should also be removed. Differential weathering and overhanging rock ledges shown will continue to degrade over time.

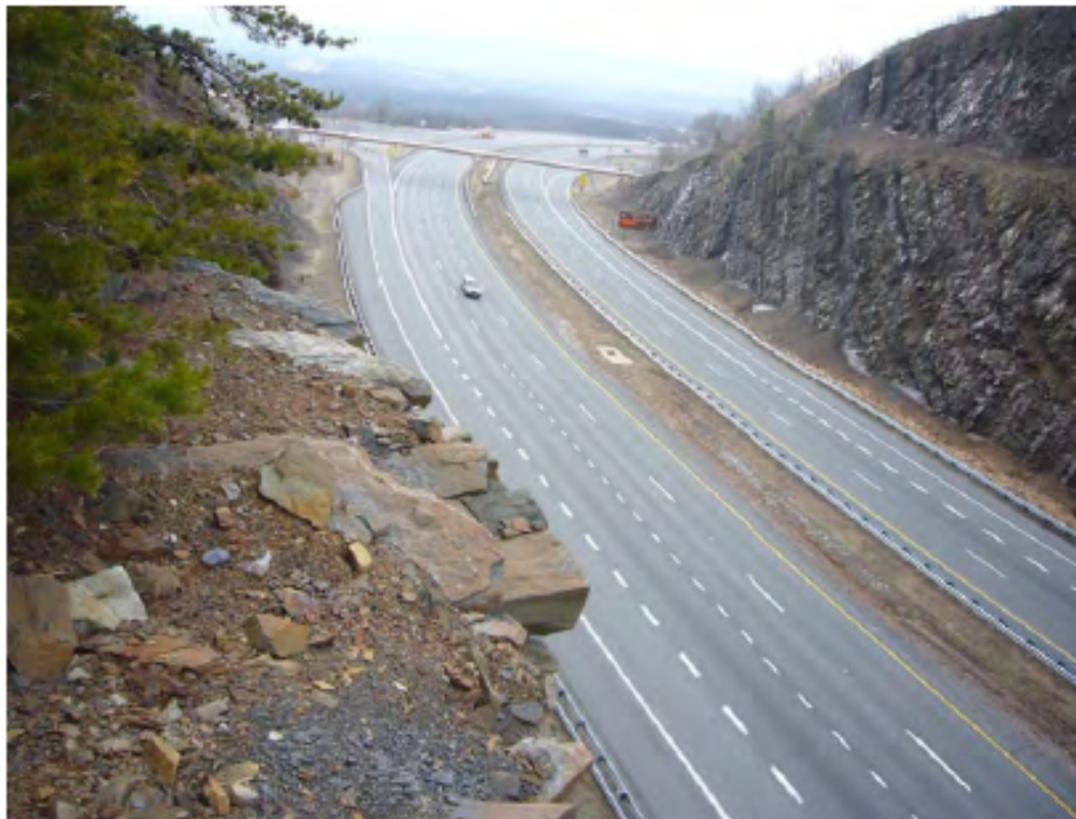
**PHOTOGRAPH No.: 5**

South Face, 1st Bench, Approx.  
Station 2485+00; looking east

Overhanging rock debris and boulders at bench edge. Loose, unstable blocks should be removed during scaling. Overhanging rocks that do not appear loose may not need to be removed. Trees on benches in steepest portions of the slope should be removed.

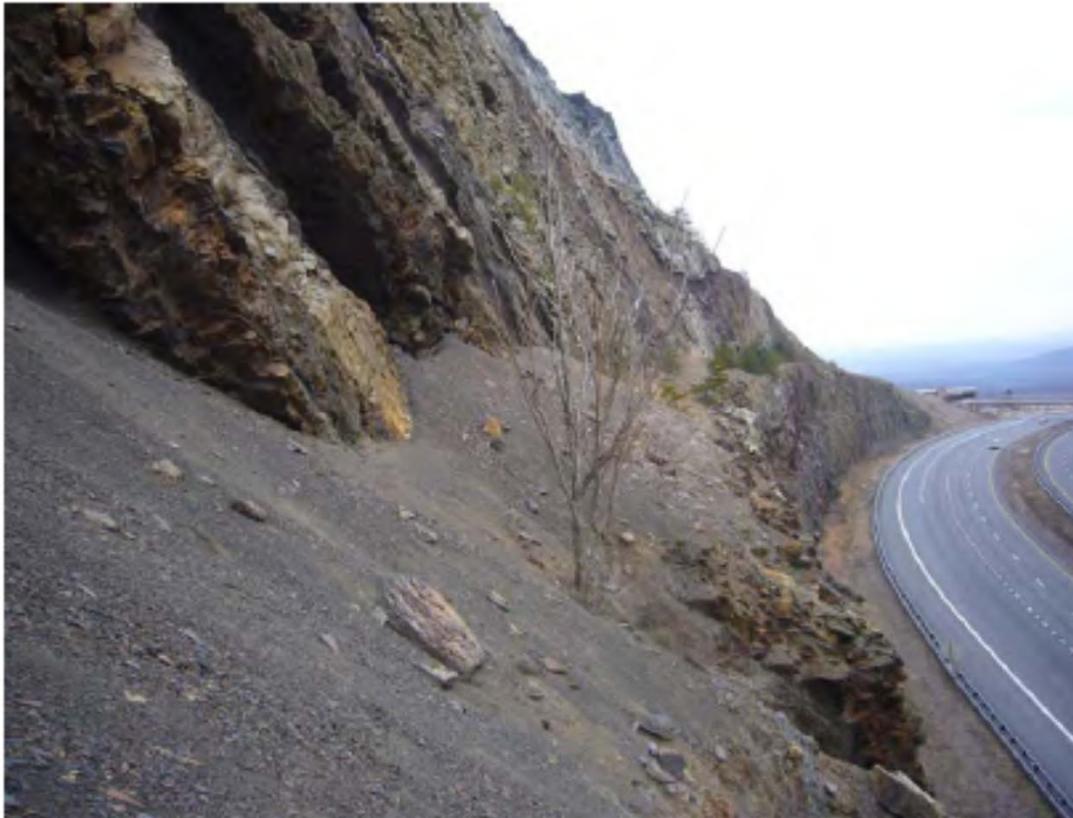
**PHOTOGRAPH No.: 27**

South Face, 1st Bench, Approx.  
Station 2492+00; looking east

Wedge of accumulated rock debris should be removed. Steepness of debris made this section too treacherous to pass on foot during the site visit.

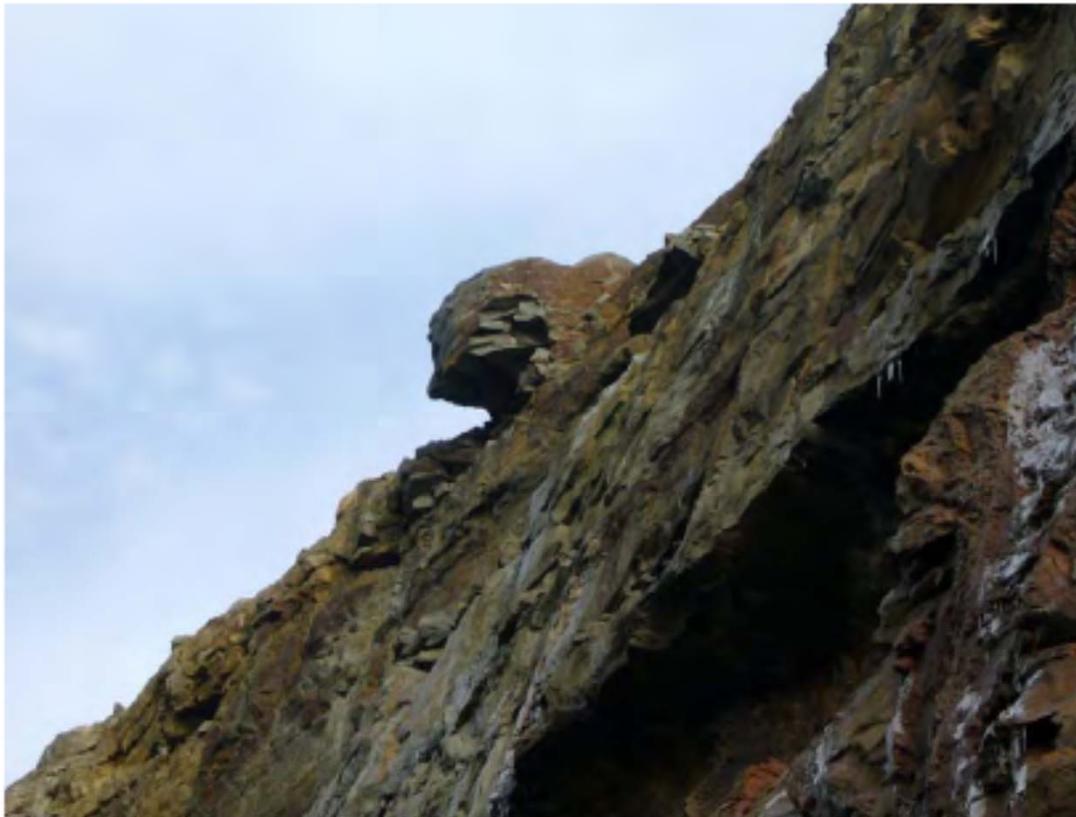
**PHOTOGRAPH No.:** 6

South Face, 1st Bench, Approx.  
Station 2485+00; looking up

Differential weathering and  
overhanging rock ledges here will  
continue to degrade over time.  
Overhanging boulder on 2nd  
bench above should be removed.

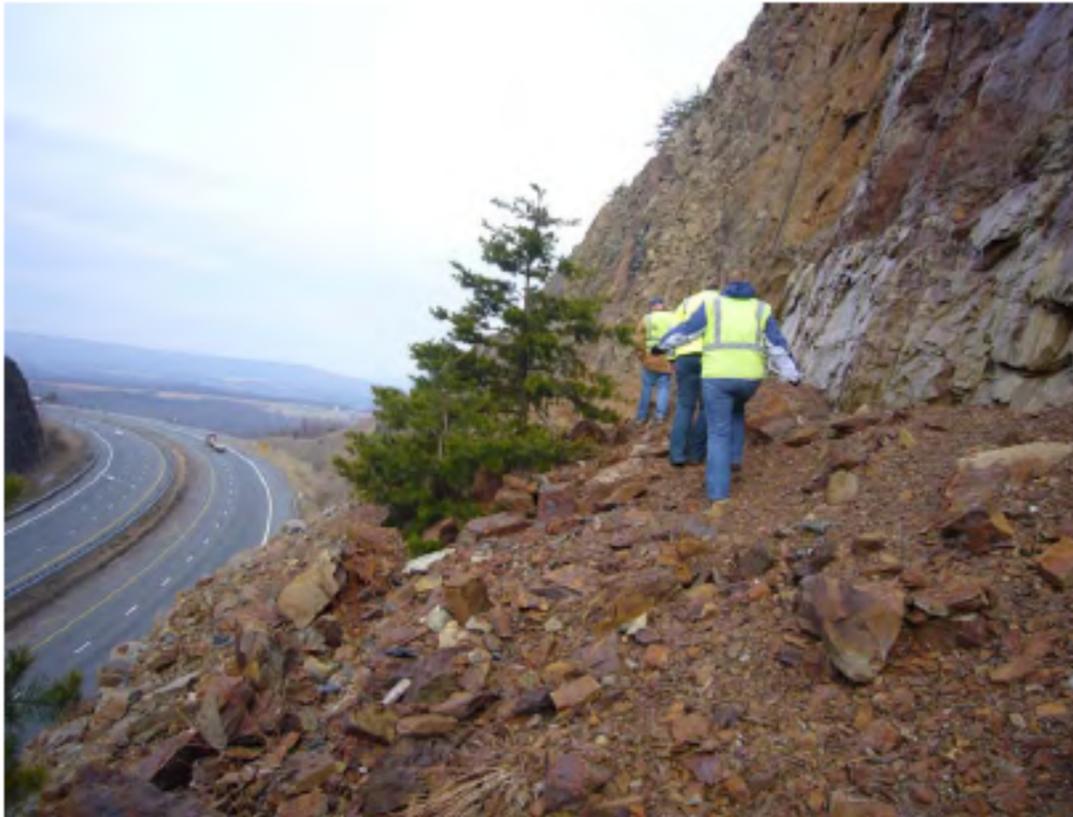
**PHOTOGRAPH No.: 7**

South Face, 1st Bench, Approx.  
Station 2487+00; looking west

Loose rock debris at bench edge should be removed. Wedge of accumulated rock debris has completely filled bench. Debris should be removed. Trees on bench near edge should also be removed.

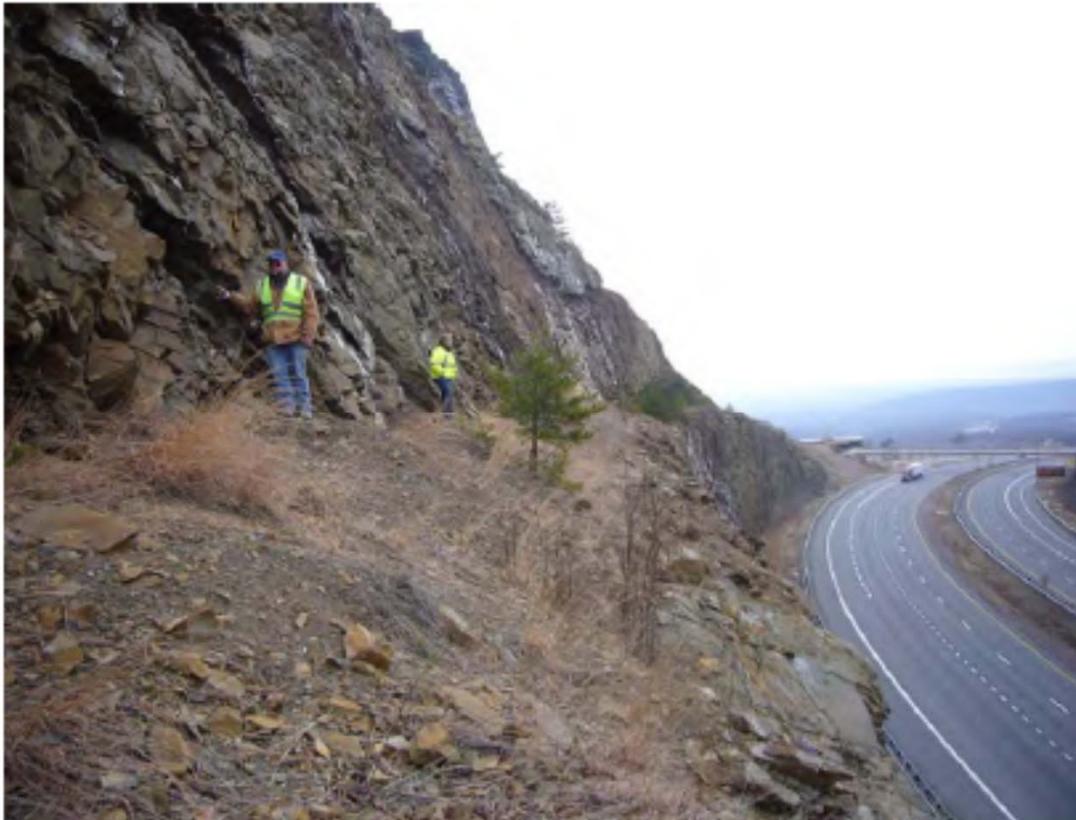
**PHOTOGRAPH No.: 11**

South Face, 1st Bench, Approx.  
Station 2490+00; looking east

Wedge of accumulated rock debris  
has filled bench and will need to  
be removed. Small trees on bench  
should also be removed.

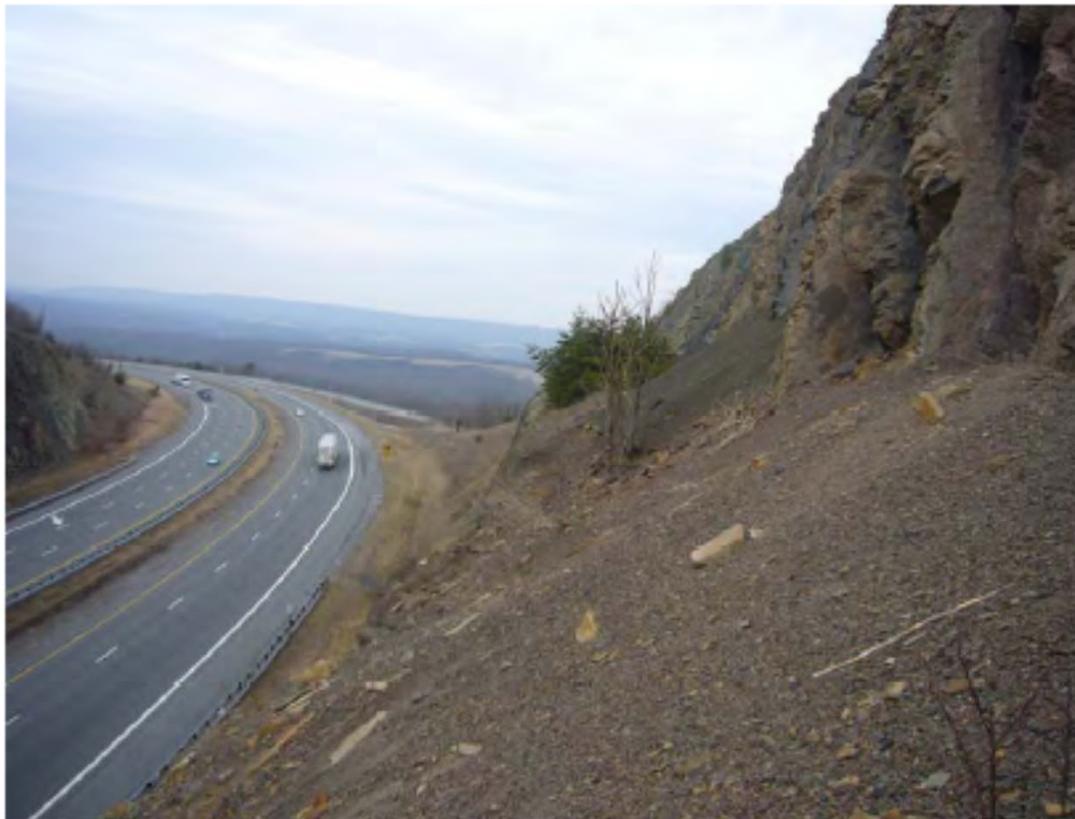
**PHOTOGRAPH No.: 13**

South Face, 1st Bench (back slope), Approx. Station 2491+00; looking west

Wedge of accumulated rock debris should be removed or regraded. Steepness of debris made this section too treacherous to pass on foot during the field visit.

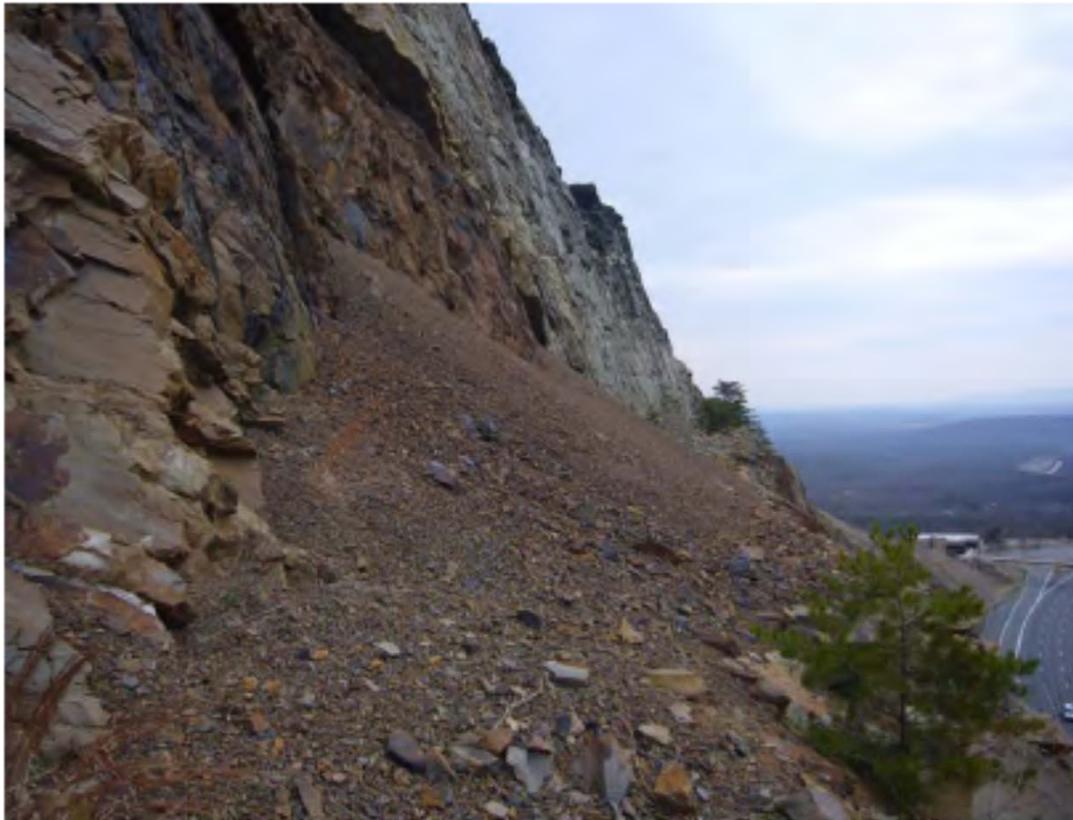
**PHOTOGRAPH No.: 25**

South Face, 2nd Bench, Approx.  
Station 2491+00; looking east

Wedge of rock debris has filled the narrow rock bench in this area and should be removed or regraded. This area was impassable on foot during the site visit due to steepness of the debris wedge. Small trees at bench edge in the steepest portions of the cut slopes should be removed.

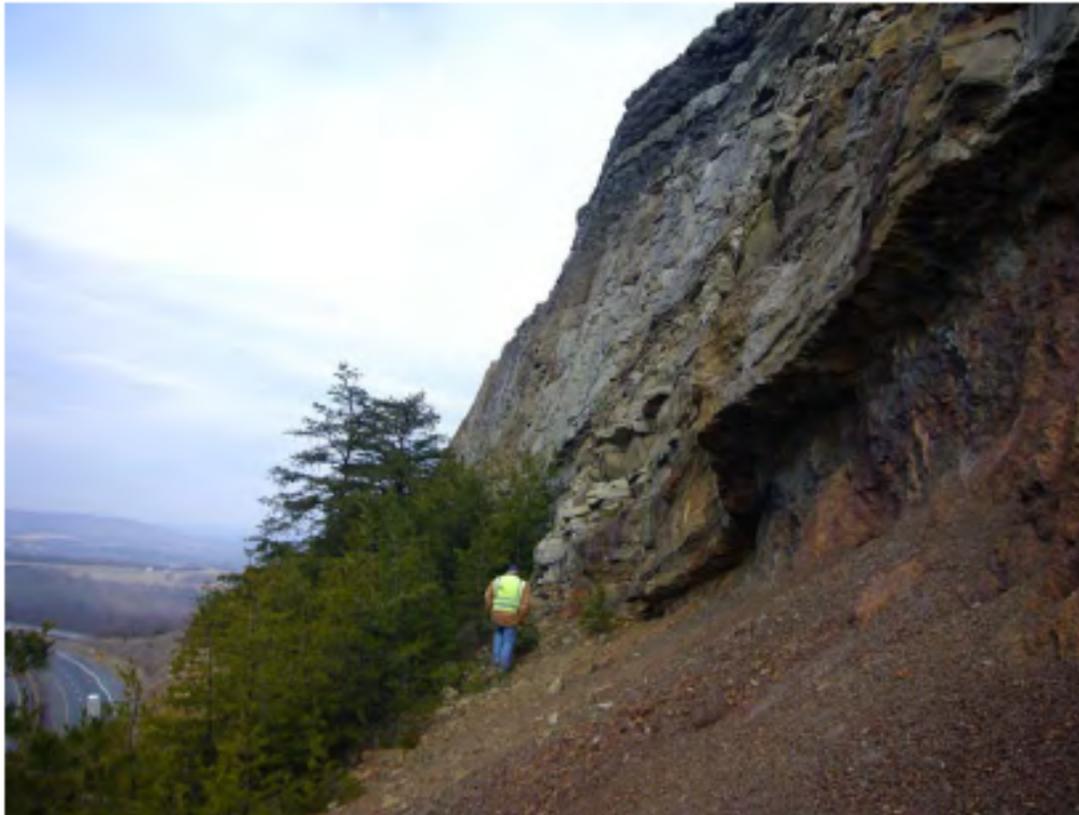
**PHOTOGRAPH No.: 14**

South Face, 2nd Bench, Approx.  
Station 2487+00; looking west

Wedge of accumulated rock debris should be removed or regraded. Trees have grown in rock debris and will also need to be removed. Differential weathering and undercut within the Rockwell Formation creates overhanging sandstone ledge in the Purslane Formation.

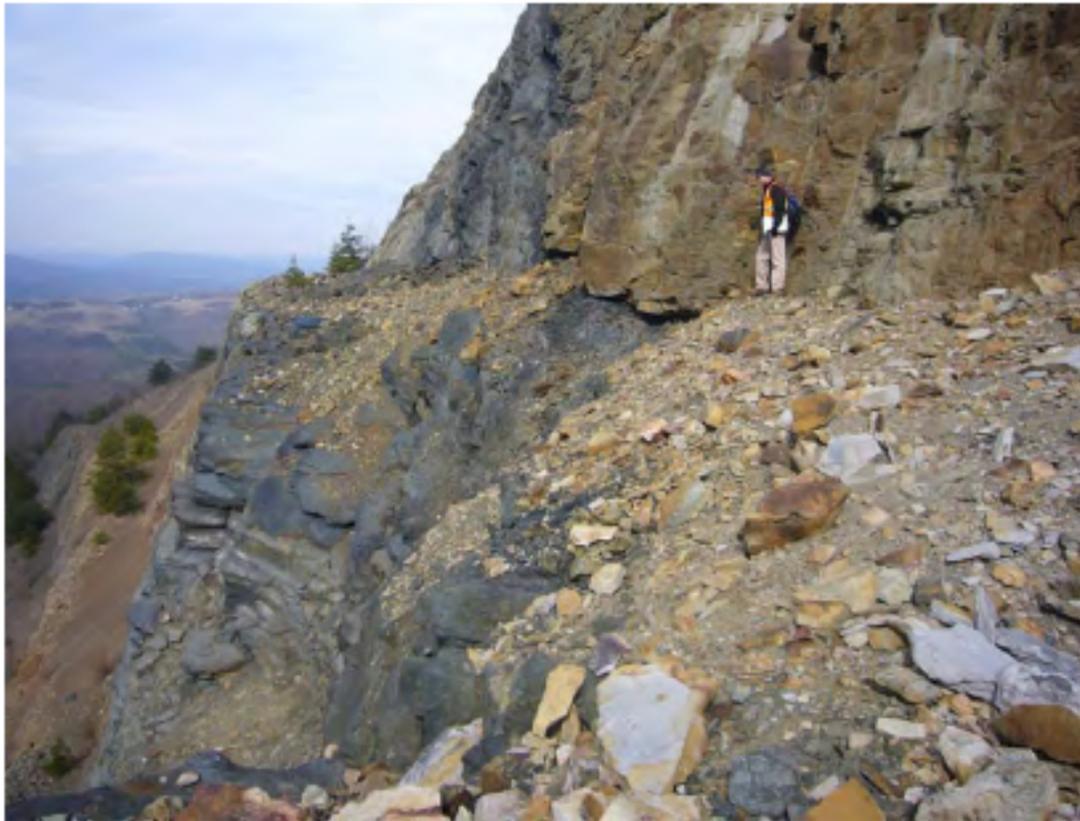
**PHOTOGRAPH No.: 17**

South Face, 3rd Bench, Approx.  
Station 2490+00; looking west

Reportedly, a large section of this bench was lost during construction. Severe differential weathering and undercutting have completely eroded the bench making it impassible during the site visit. The faulted, coal-bearing beds are particularly susceptible to differential weathering effects. Loose rock debris on the edge of the bench should be removed during scaling.

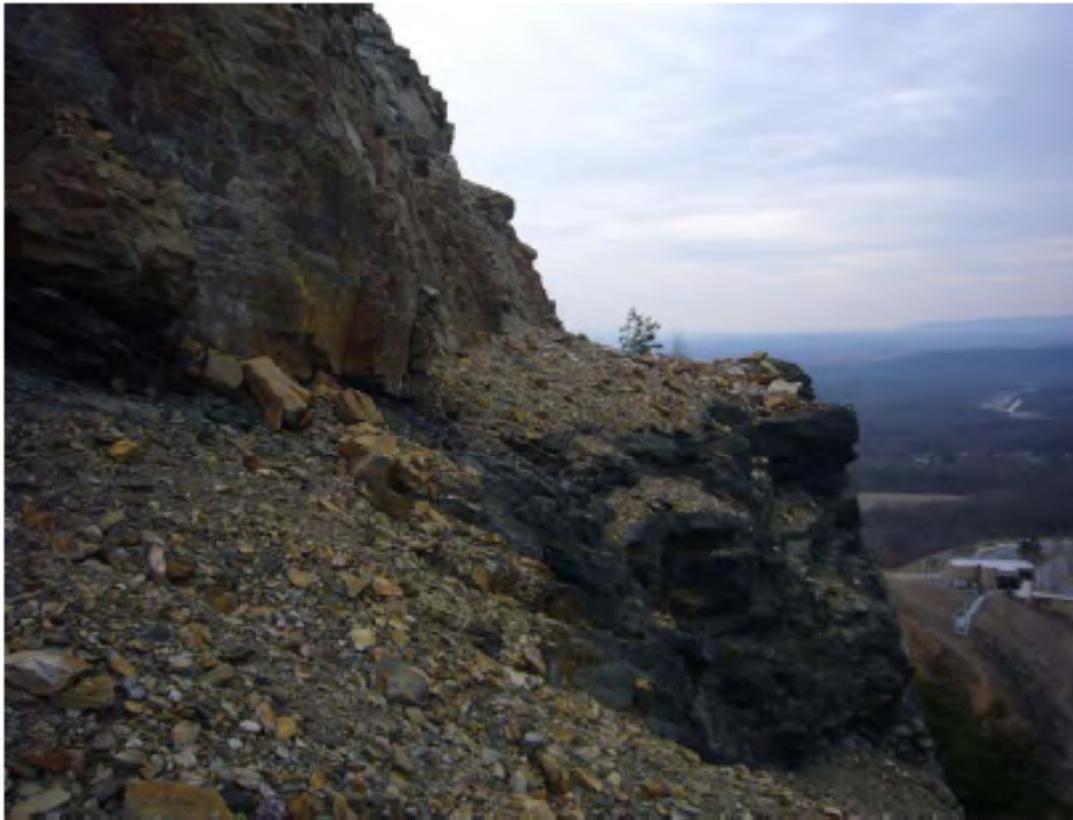
**PHOTOGRAPH No.: 23**

South Face, 3rd Bench, Approx.  
Station 2491+00; looking east

Severe differential weathering and undercutting have completely eroded the bench in this area making it impassible during the site visit. The coal-bearing beds in this area are particularly susceptible to differential weathering effects. The slope will continue to degrade over time in this area, increasing the rockfall hazard. Loose rock debris on the edge of the bench will need to be removed.

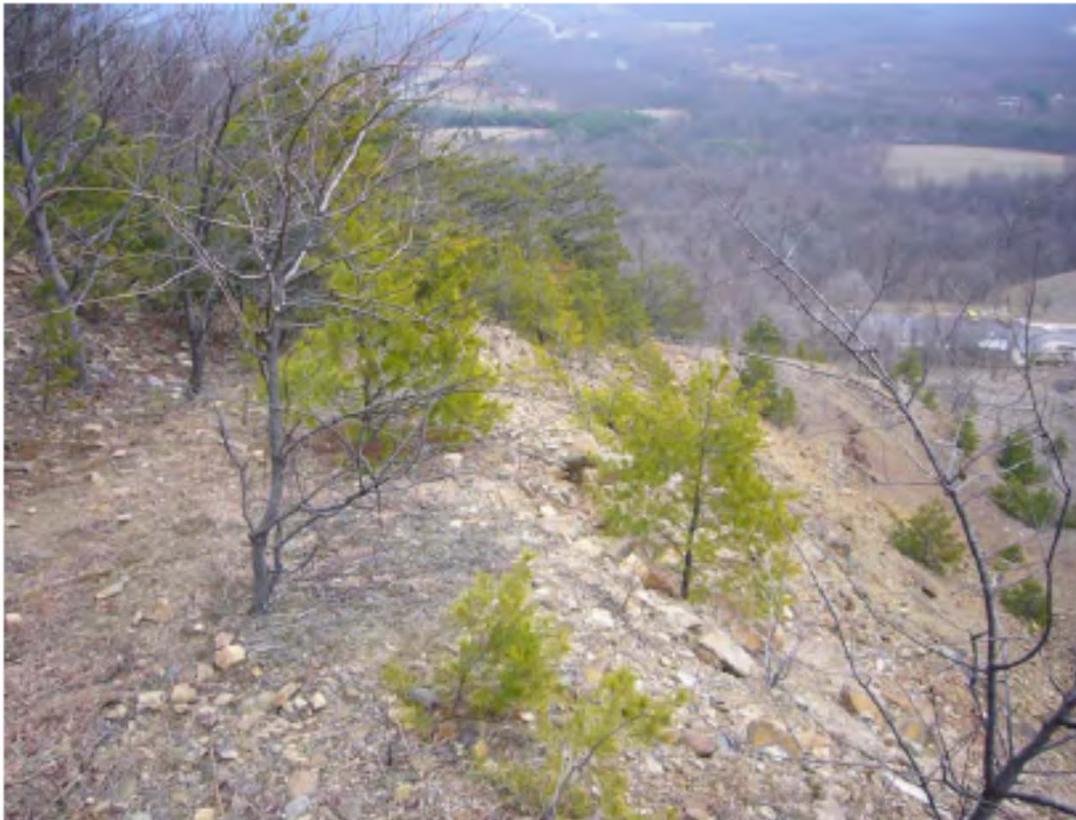
**PHOTOGRAPH No.:** 20

South Face, 4th Bench, Approx.  
Station 2486+00; looking east

Benches at the east and west ends of the cut slopes appeared relatively stable compared with the steeper portions of the slopes. Trees in these areas do not need to be removed unless they are deemed to increase the rockfall hazard on a case by case basis.
